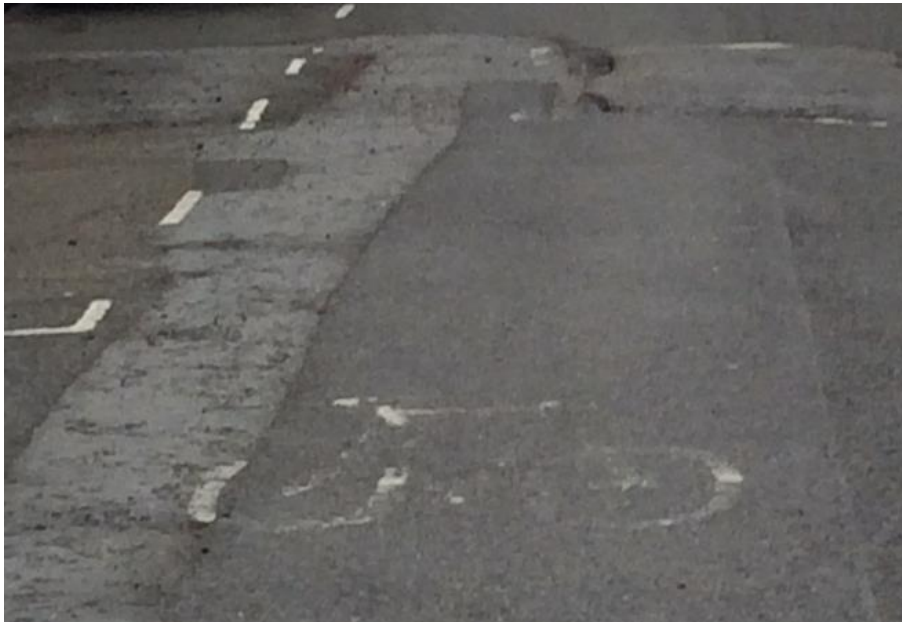
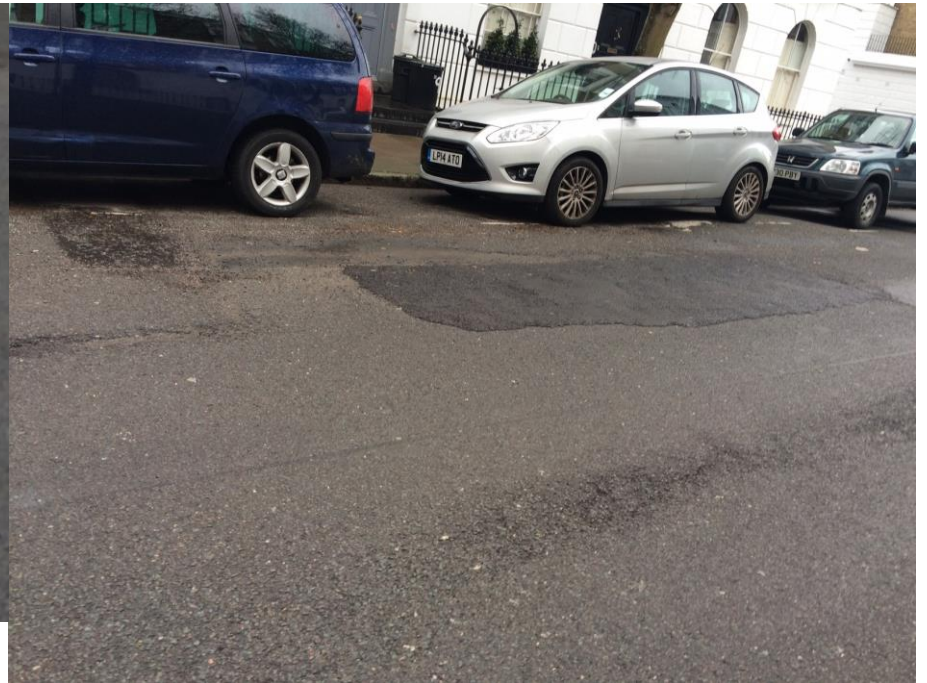
State of road surface is poor and poses risk to cyclists

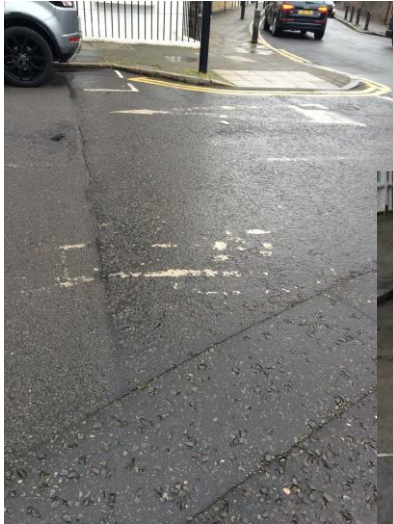
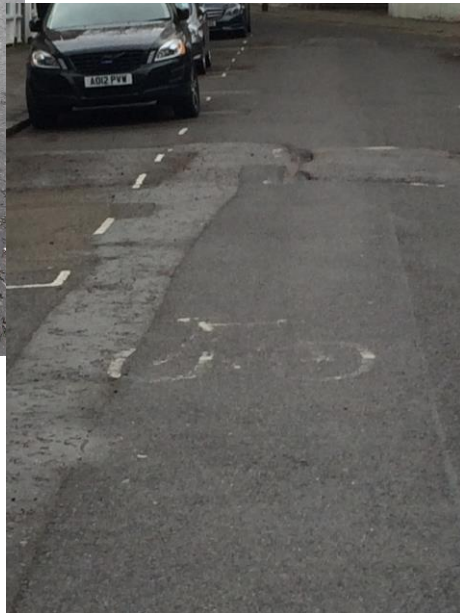
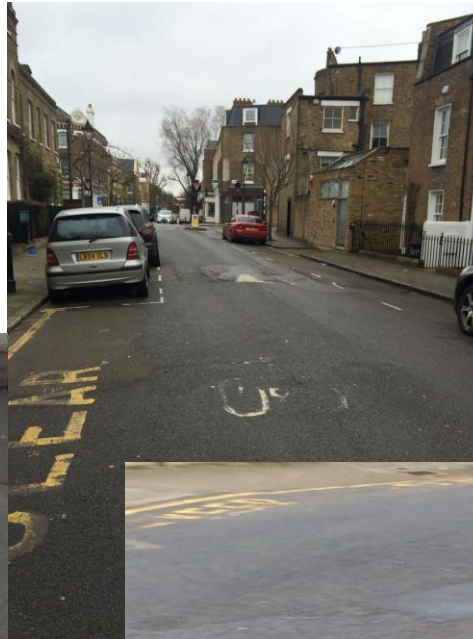
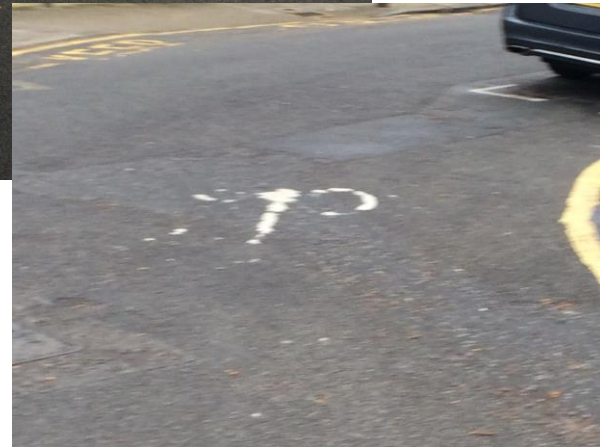
Cycle road markings almost completely worn off and impossible to see, especially motor vehicle drivers

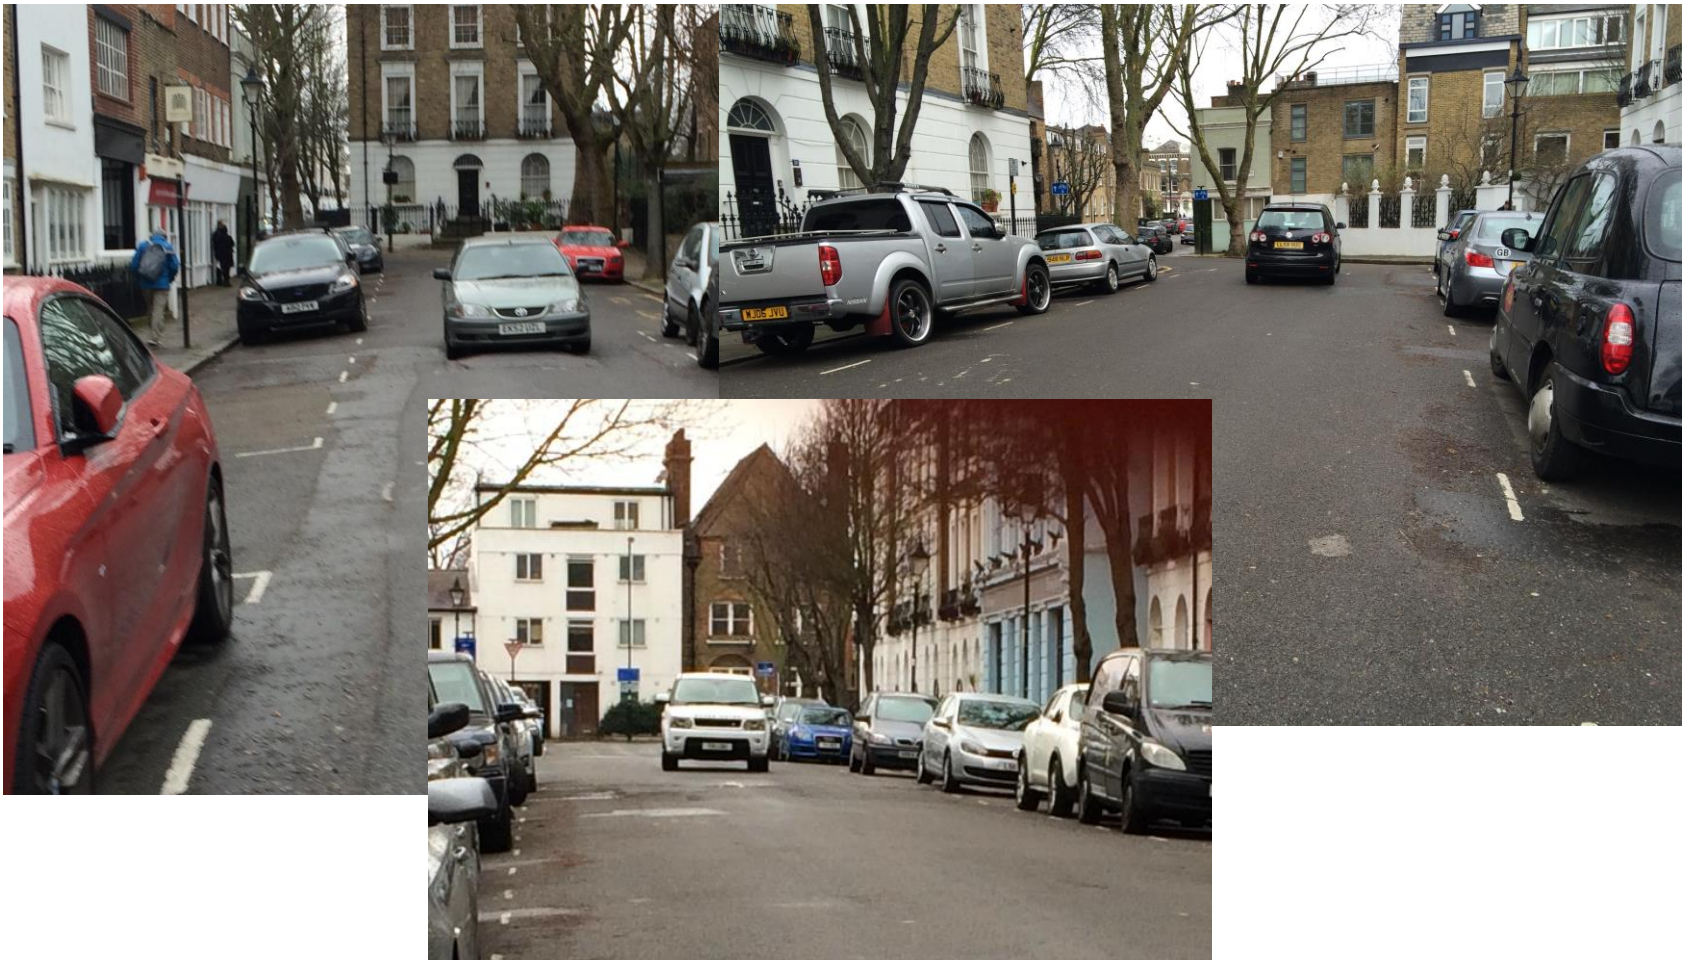
Motor vehicles move to centre of road to straddle the speed bumps:
on both the two way and one way / cycle contraflow sections

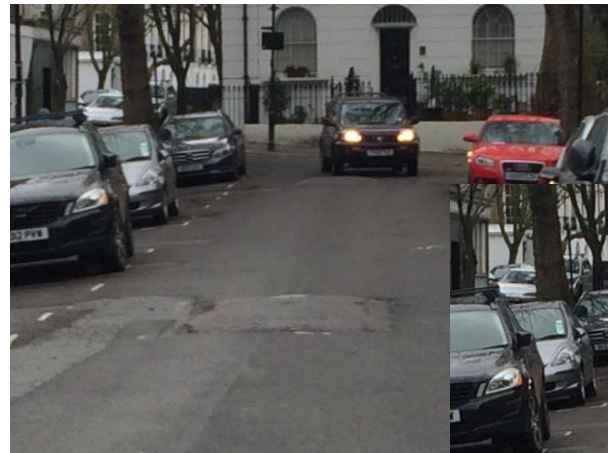
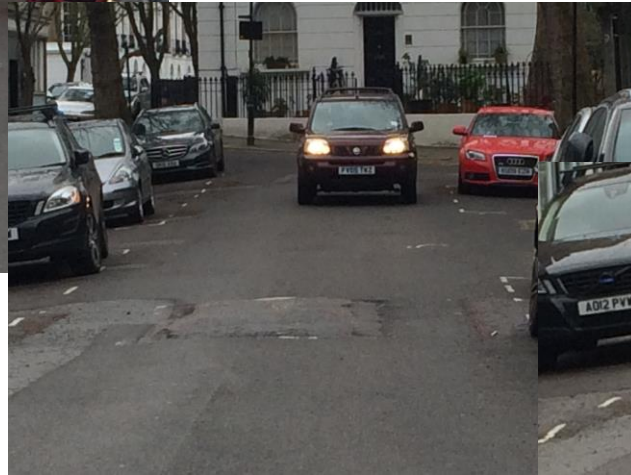
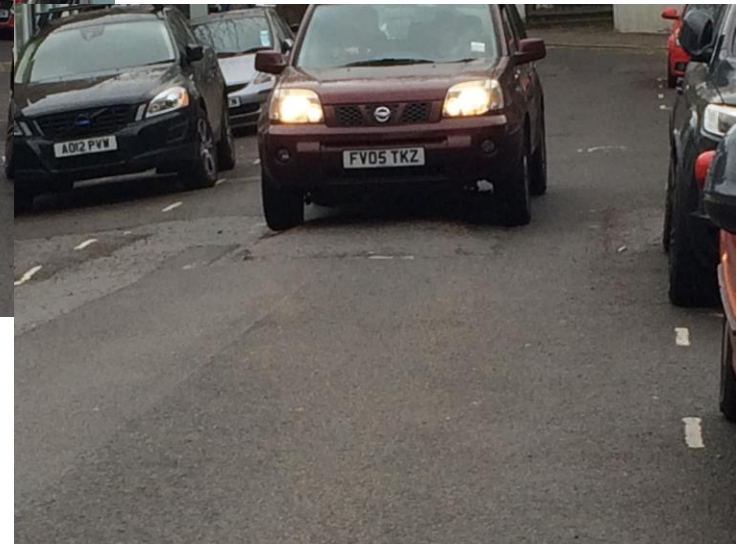
Motor vehicles move to centre of road to straddle the speed bumps:
Both the two way and one way / cycle contraflow sections

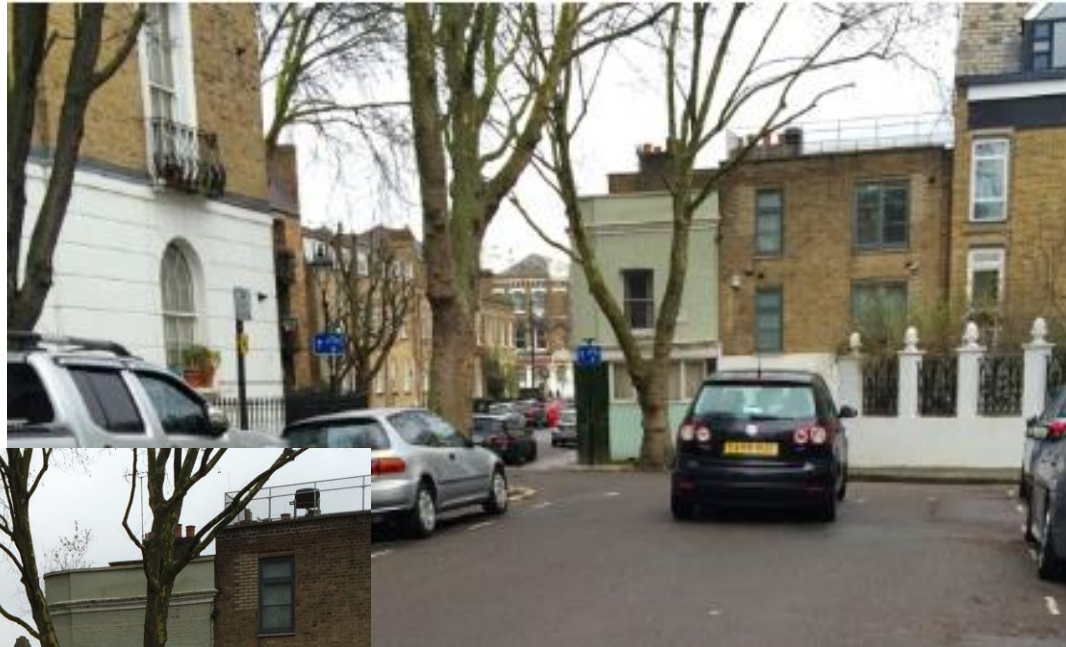
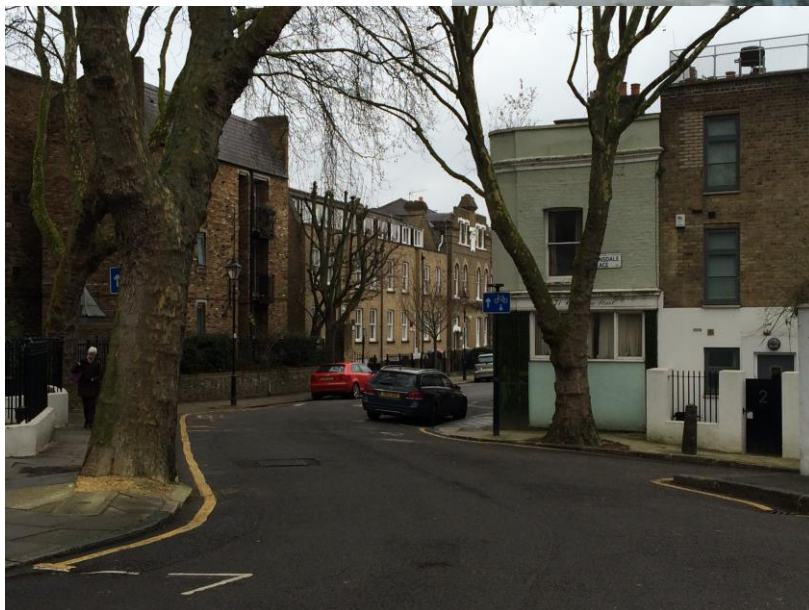
Cycle contraflow signs high and difficult to spot,
Tree position occludes left hand sign from view

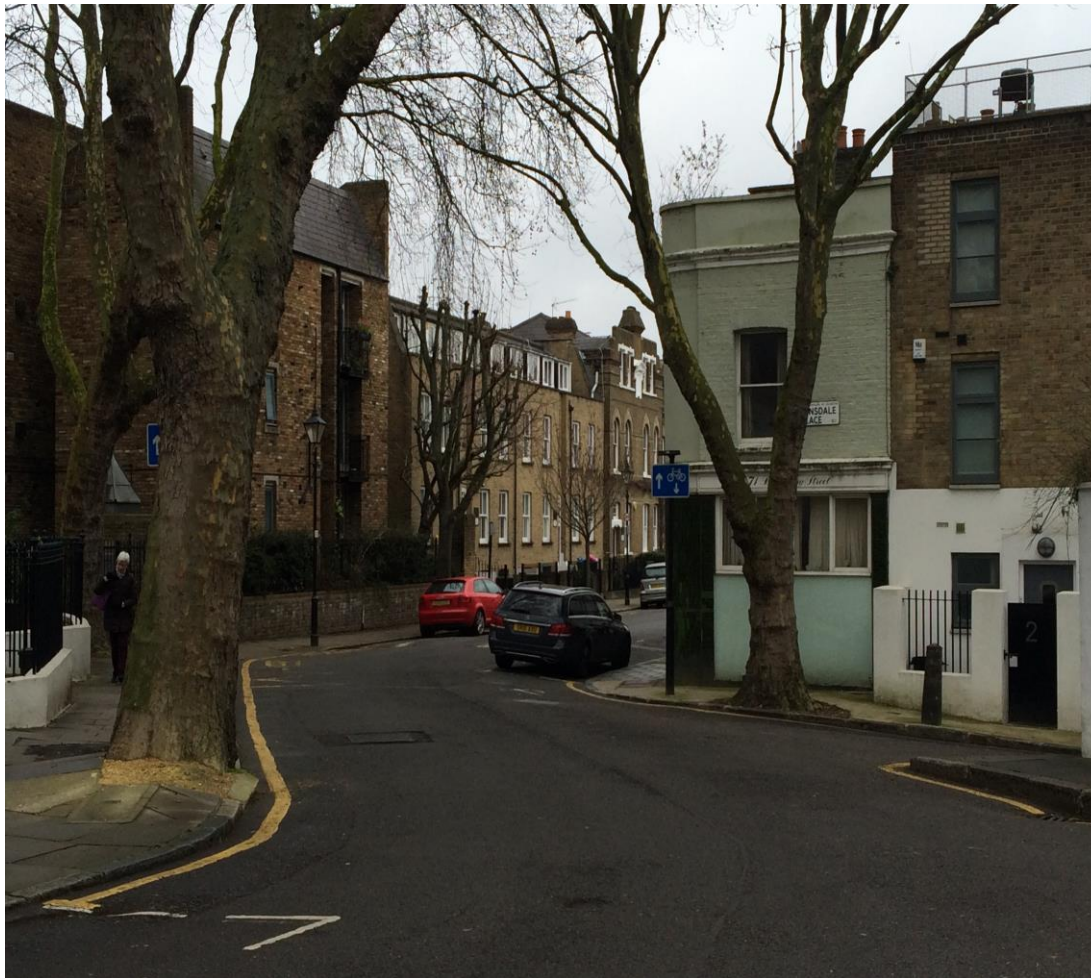
Narrowing of road leaves little room for contraflow cycles and oncoming traffic
Double bend in road forces all traffic into centre, with risk to oncoming contraflow cyclists

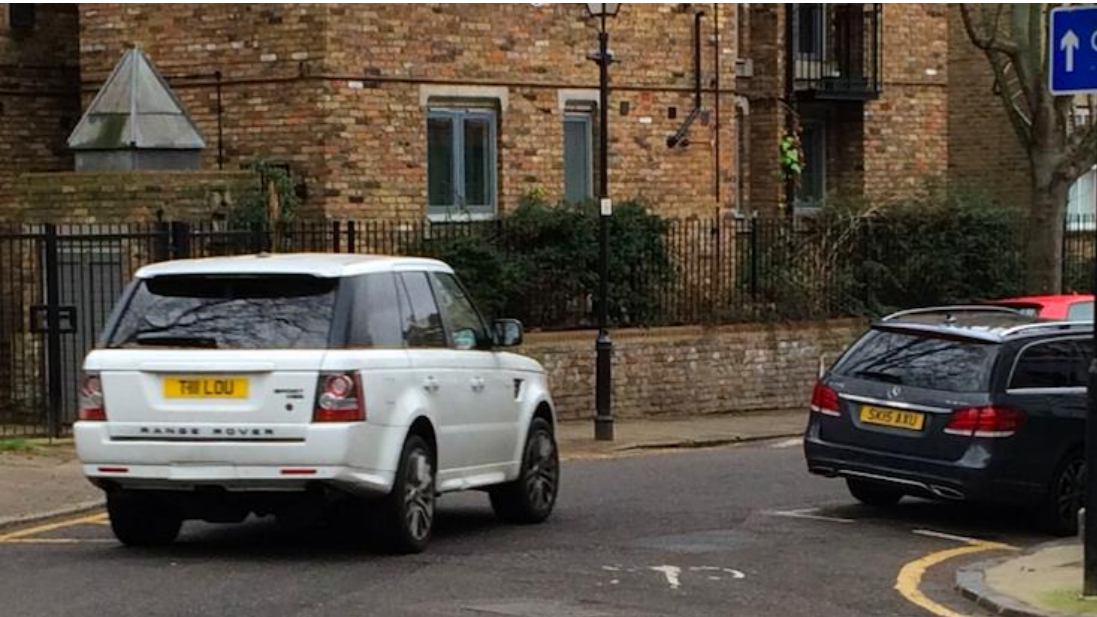
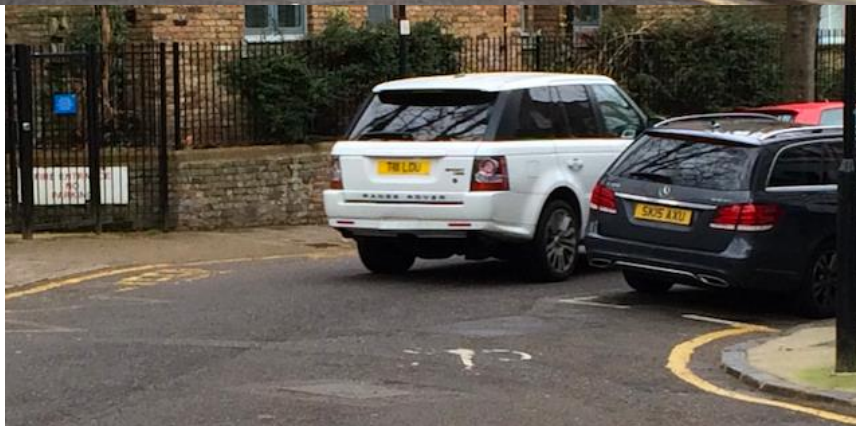
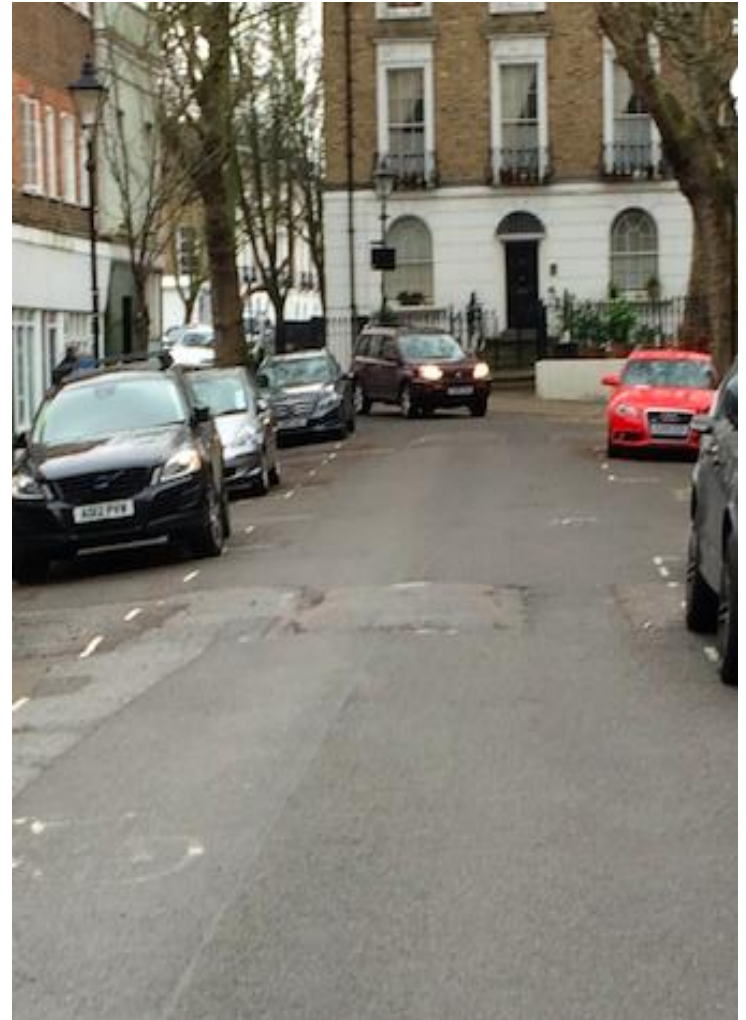
Narrowing of road leaves little room for contraflow cycles and oncoming traffic

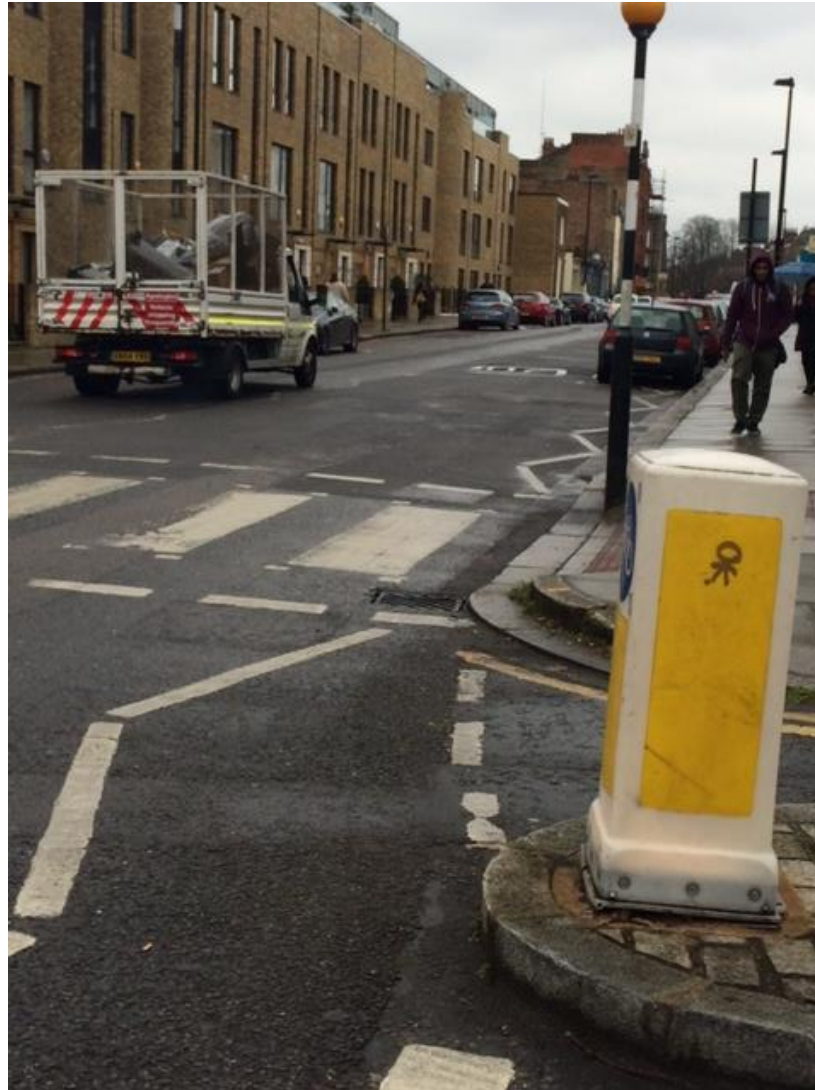
View when looking right at junction with Liverpool Road – angle of road, parked cars and pole make it challenging to see oncoming traffic especially when traffic approaching at speed
